# Report for Wellington City Council

## Community Street Review for Brooklyn, Wellington

Revised version, April 2009

**Living Streets Aotearoa**

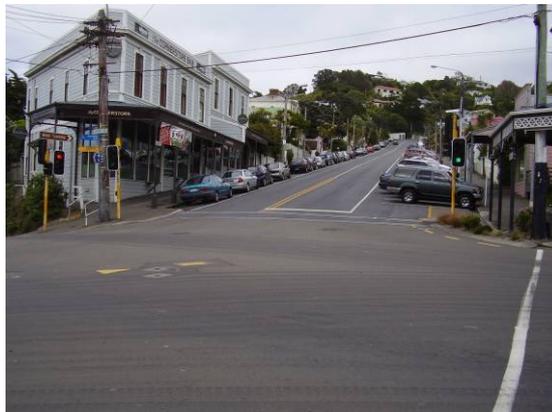
##### 1R Ohiro Road / Todman Street Intersection

Although this intersection has an overall walkability rating of A, participants felt under pressure from vehicles turning left from Ohiro Road into Todman Street. This was partly due to the fact that vehicles have to stop and start on a hill and they need to accelerate harder to get up it, making them approach the crossing faster than they perhaps normally would.

The pedestrian phase was considered to be too short, not allowing pedestrians enough time to cross. This is a particular problem at peak times when large numbers of people are crossing at the same time.

The starting point of Feeder Route 1

- That more priority be given to pedestrians crossing the street.
- This would be best achieved by having a red traffic light for left turning vehicles during the pedestrian crossing phase. Alternatively extending the pedestrian crossing phase, particularly during peak hours would improve pedestrian safety.

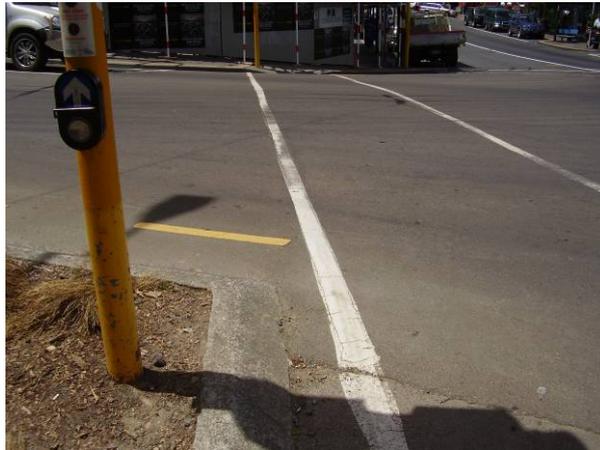
##### 2R Crossing Ohiro Road at the Ohiro Road / Cleveland Street Intersection

Again, participants felt under pressure from turning vehicles. The pedestrian phase was too short, with the signal turning red before pedestrians were even half way

across. The access to the walk signal button on the crossing was not easily accessible. The slope kerbing prevents less able-bodied people from reaching across to press the button.

- Increase the length of the walk signal
- re-position the signal button or kerbing to allow access to the signal button.

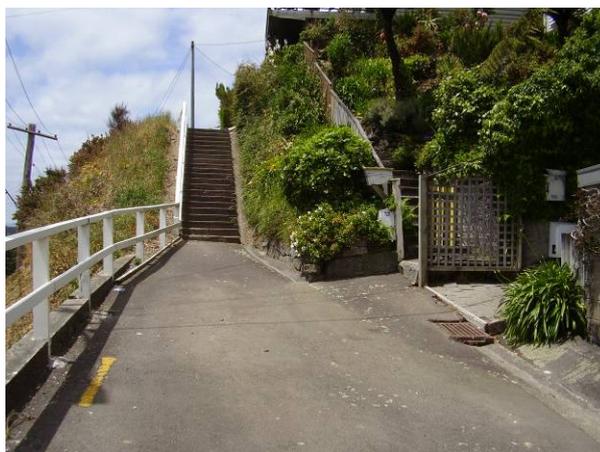
2P *Full length of Brooklyn Terrace (a link section)*

This pathway provided a pleasant walk away from the traffic, but was poorly maintained. The path is eroding, the bank is crumbling and the steps are uneven with corners missing. Personal safety was an issue and the two street lights were considered insufficient.

At the time of the review, a car was parked at the bottom of the steps, making access difficult. Rubble and twigs covering the pathway looks messy and could be dangerous underfoot.

- Improve surface quality, to ensure a smooth, safe walking environment
- Ensure regular clearance of street debris and litter
- Add extra street lighting
- Extend the yellow, no parking, lines to prevent vehicles blocking pedestrian access to the steps.

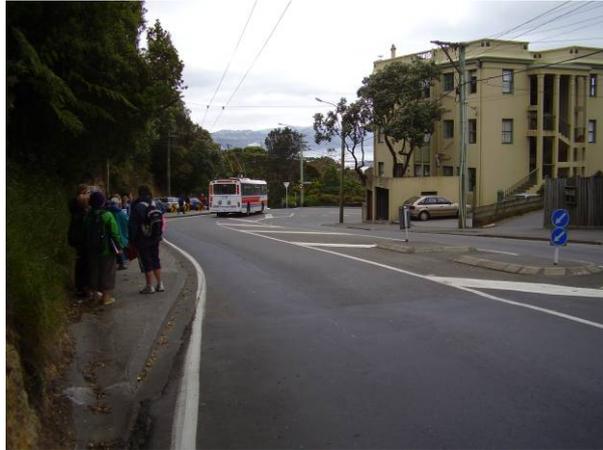
4R *Ohiro Road (crossing mid-block at pedestrian refuge)*

This crossing achieved a low score for the main reason that is in an unsuitable and unsafe location. Traffic speed is too high. Vehicles are accelerating around a bend to get up the hill where the crossing is located, making it difficult for them to stop. The speed of traffic makes it difficult for pedestrians to judge when it is safe to cross.

In addition, the road markings are poorly visible for both vehicles and pedestrians. Drivers would therefore not expect to find pedestrians crossing and would struggle to slow down or stop at short notice. One participant quoted that people have to 'take their life in their own hands' to safely cross at this location.

Move the crossing to a more suitable location and make it a signalised pedestrian crossing.

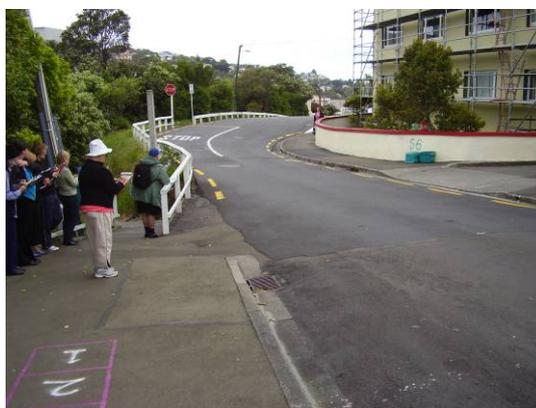
5R *Helen Street*

At this crossing, the visibility of cars approaching from the left is poor, making pedestrians rely on the sound of approaching traffic. Obviously this would be difficult for the hard of hearing. It was also considered difficult for drivers turning into Helen Street to see pedestrians crossing until they were around the corner, and vice versa. There was no ramp on the South side of the crossing.

The starting point of Feeder Route 2

- Install signage to warn drivers that there is a pedestrian crossing and to slow down.
- Improve road markings to make the crossing more visible to drivers
- Possibly install a zebra crossing further up Helen Street

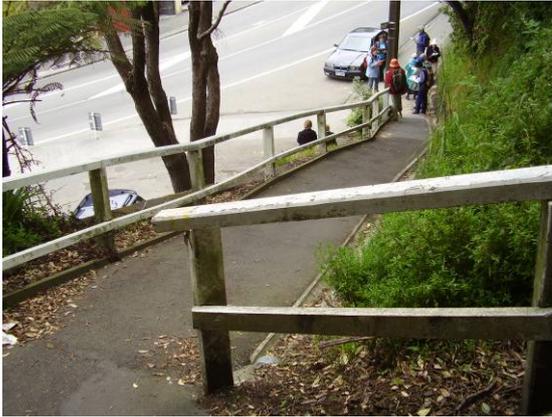
While the participants thought this ramp was pleasant, they also thought it was very steep, making it difficult or even impossible for wheelchair users and those with pushchairs to use. The alternative route down to Ohiro Road is via Tanera Crescent, however there is no footpath at the end of Tanera Crescent, for those wanting to turn left down Ohiro Road. Anyone using this route would need to go out into the traffic to pass the cars that park alongside the wall that leads to the footpath.

The very steep pathway

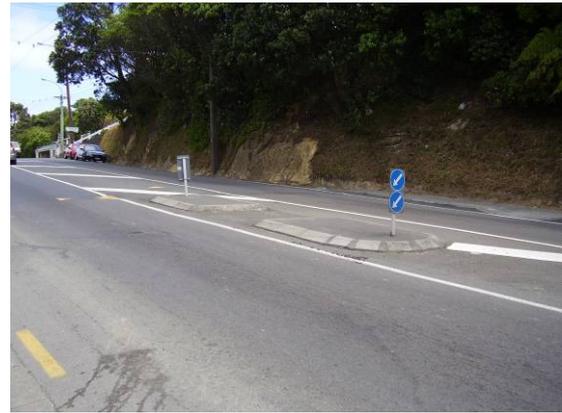
The alternative route without footpath

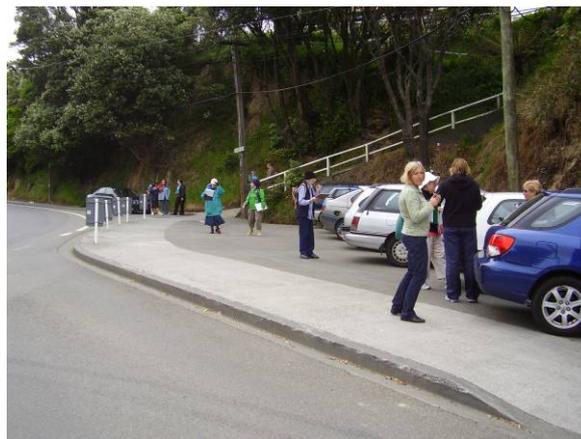
5P Ohiro Road, from mid block crossing to Brooklyn Road intersection, passing car park

There was a lot of debris on the path which could contribute to slips or falls after rain. The path also does not flow nicely, changing direction from what would be the natural path.

Cars have to cross the pedestrian footway in order to access the parking area. This is not considered safe for pedestrians, particularly the less mobile. At the time of the review a car was parked across the exit ramp meaning that cars leaving the parking area needed to use the footpath and drop down the kerb to leave. Generally the area was considered to be unattractive and unfriendly with significant room for improvement.

- Improve the attractiveness of the area using planting.
- Replace the parking area with a feature area with seating.

- One participant suggested that the bend leading down Ohiro Road should be re-shaped, making the flow of traffic easier, removing the need for the signage, and improving the flow of the footpath.

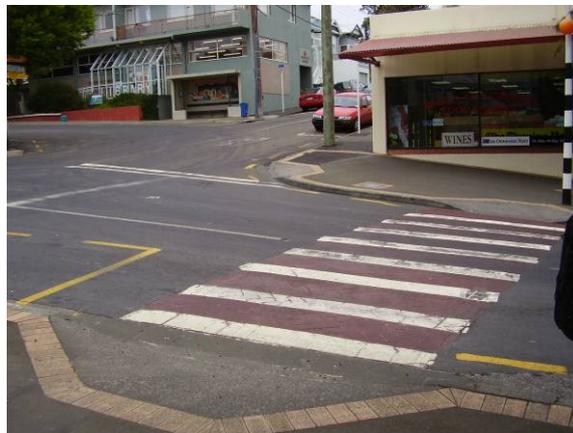
This was generally a good crossing, with good visibility of approaching traffic. As the crossing is situated close to the intersection with Jefferson Street and Harrison Street, pedestrians need to be vigilant for traffic coming from four different directions. Cars often park close to the crossing on both Harrison Street and Cleveland Streets, despite yellow lines.

- Increase traffic warden frequencies
- Run a month long parking campaign to reduce illegal parking.

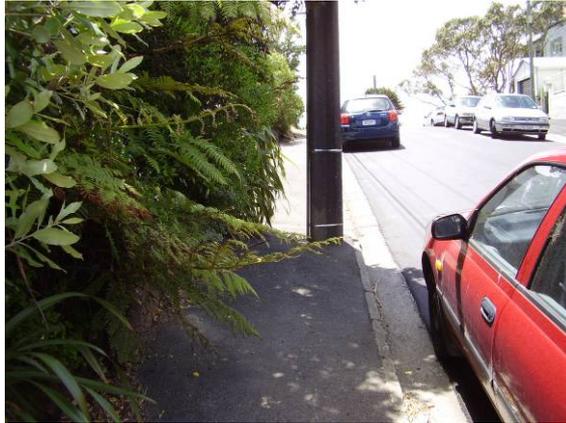
This was a pleasant walk, away from traffic, but was poorly maintained. Parts of the footpath were quite heavily littered with rubble, leaves and rubbish. In addition, the already narrow footpath was obstructed with a power pole and overhanging vegetation. This necessitated stepping into the road in order to pass. There were also holes in the tarmac.

- Cut back the vegetation as a priority and ensure regular vegetation maintenance.
- Ensure regular litter and debris removal
- Repair holes in the tarmac

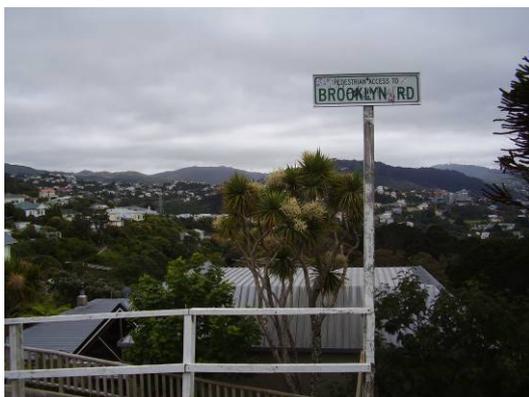
This sign doesn't say which direction the access is.

- Repair and paint the handrail
- Ensure the path is regularly cleared of debris
- Improve signage to highlight the pedestrian access from both directions

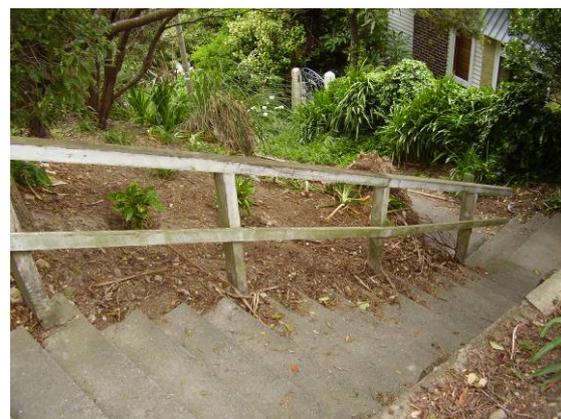
Handrails sections are missing, whilst others are in need of repair. The footpath was uneven with lots of debris which could be dangerous when wet. The concrete at the top of the steps was cracked and, although there is some signage to the pathway, it is not very clear. The street lighting is also considered inadequate. *(Note that for pedestrians coming up the steps in the opposite direction there is no signage to tell them that they are on Jefferson Street).*

Handrail and walkway looking scruffy

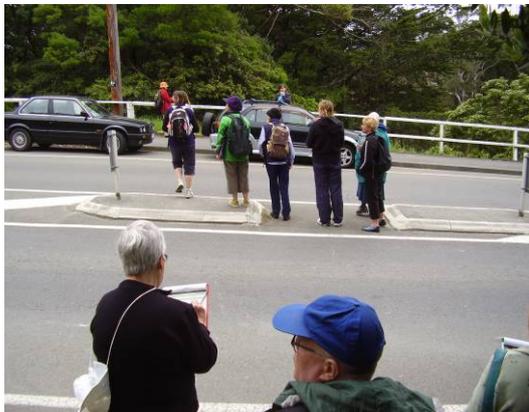
At this crossing a car was parked, obstructing the crossing exit on the park side of Brooklyn Road. The car was parked legally in a marked space. There was no ramp on either side of the crossing for pushchairs or wheelchairs.

The car blocking the crossing exit

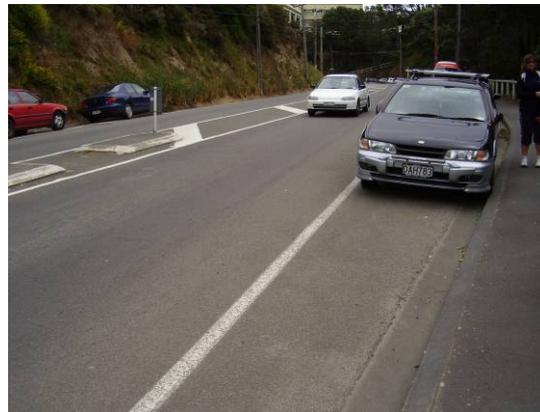
The lack of ramp access

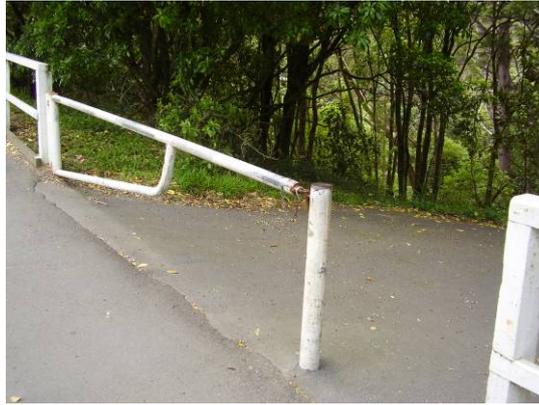
This footpath was very pleasant, safe and away from traffic. The mature trees were appealing and the maintenance levels were good. There was gravel on the footpath making it slightly slippery. One person felt unsafe because it was quite isolated. Two people also commented that cycles and skateboards can cause a hazard for walkers.

One participant commented that the entrance to the park looks unfriendly and like it's for cars only.

- Improve landscaping at the entrance to make it more welcoming.
- Keep grass on either side of the footpath well trimmed.

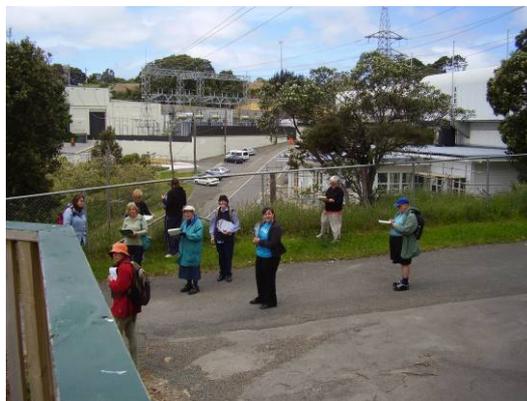
This was a very pleasant footpath. However the surfacing was uneven in places and the lighting levels could be improved.

- Resurface the footpath
- Install extra lighting
- Plant shrubs by the fence on the street side of the path to further enhance the pathway.

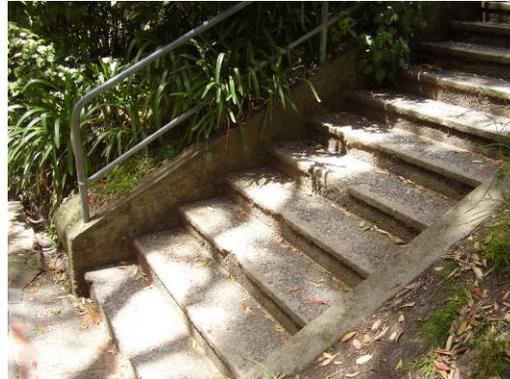
There were leaves, twigs and gravel on the path, which were a trip hazard and in need of frequent attention. The path was in need of maintenance and the steps are chipped and in need of repair.

There were poor lighting levels and when combined with the site's isolation, some reviewers felt that personal safety would be an issue.

- Repair the chipped steps
- Install more lighting.

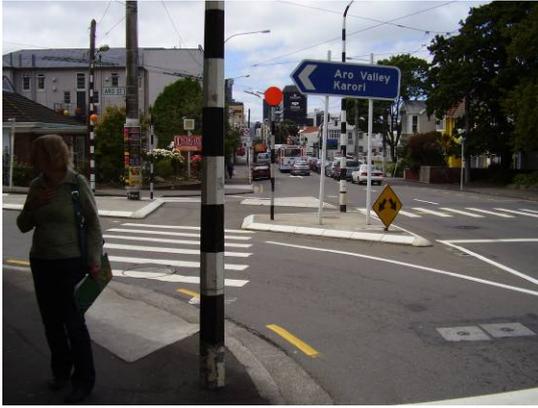
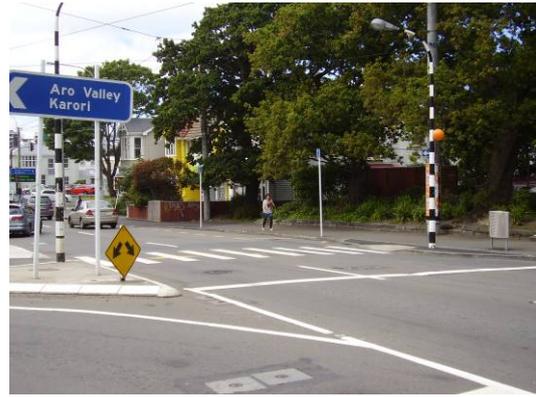
These crossings, while looking unsightly, are actually sensible and functional. There is good vision of traffic from all directions, however they are busy routes and vehicles approach very fast so pedestrians must be very cautious when attempting to cross. One person commented that they avoid these crossings if possible.

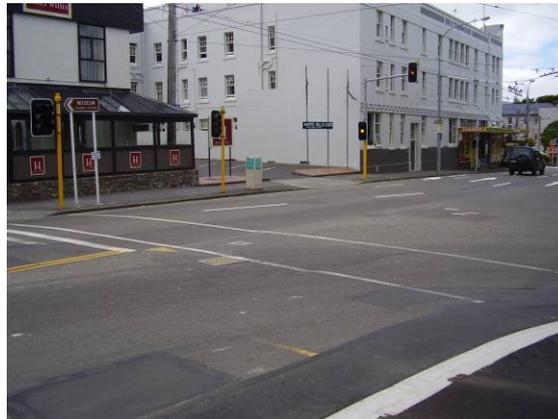
13R Willis Street / Webb Street intersection (crossing Willis Street) (link crossing)

The wait for the walk signal was far too long with the priority obviously for vehicles at this intersection. The pedestrian crossing phase was also too short, making the reviewers feel pressured to cross quickly. This is clearly not accessible for the mobility impaired or slower people.

- Reduce the pedestrian waiting time
- Increase the pedestrian crossing period.

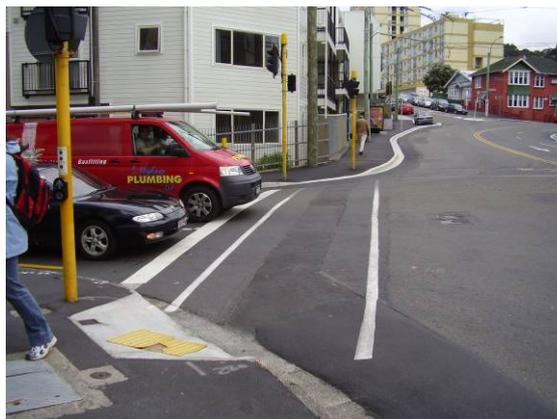
At this crossing, there was a broken yellow tactile crossing tile causing a trip hazard on the North side. The ramp on this side is also too steep and angled wrongly. This would cause confusion for the visually impaired and difficulty for pushchairs and wheelchairs. The road surface is also uneven in places. Again the waiting time was too long.

- Reduce the pedestrian waiting time.
- Extend the width of the North side ramp, on either side of the current ramp, to enable wheelchair users to approach the ramp at the correct angle.

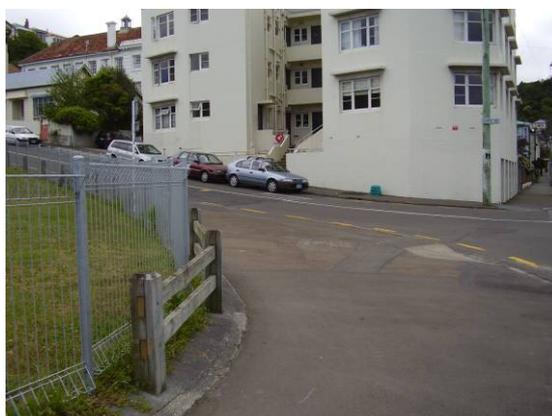
There was loose gravel on the path in the upper part of the section, which can be hazardous.

Whilst the walk is picturesque and pleasant, a patchy uneven surface gives it an overall neglected look. The traffic is heavy, fast and noisy. One reviewer commented that there are usually cars parked on the footpath in this section, however there were none at the time of the review.

- Clear the loose gravel and resurface the footpath to give an even and more attractive appearance. Install extra seating for added value.

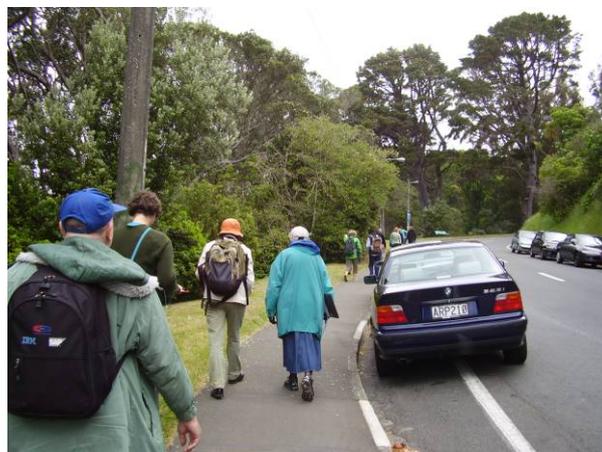
This is a very pleasant footpath, and the seat at the top is perfectly situated. A drinking fountain would be an interesting addition. Some leaves on the footpath, could become a slip hazard when wet. Personal safety was an issue raised for after dark.
