Living Streets Aotearoa

Community Street Audit – Pilot Project June 7th 2005

Conducted by Wendy Everingham, Living Streets Aotearoa - Canterbury Branch

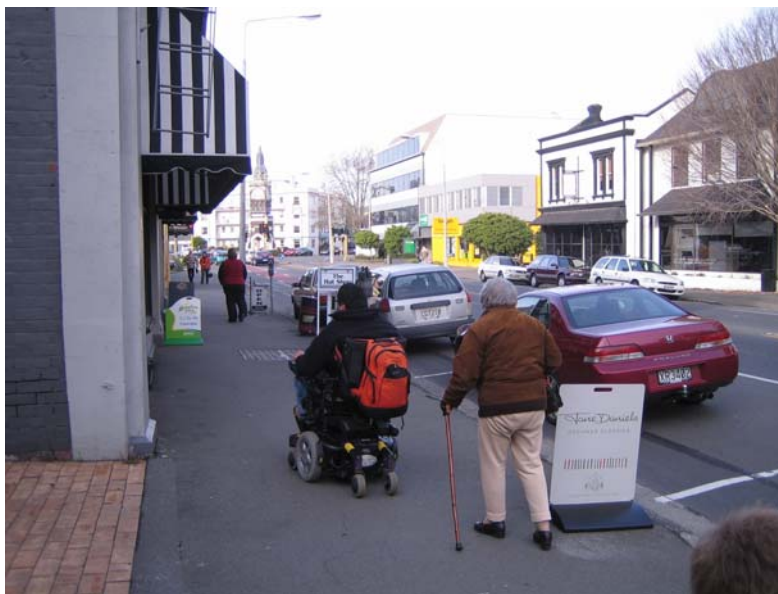
Sandwich boards and obstructions were all over the pavement. This made it particularly difficult for our vision-impaired person.

- Ensuring that signboards are aligned to kerb edges, not all over the pavement. I would imagine this would not be terribly difficult to implement. Parking wardens could report areas where this is a problem and council staff could then educate/inform shop owners that boards should be aligned to the kerb.

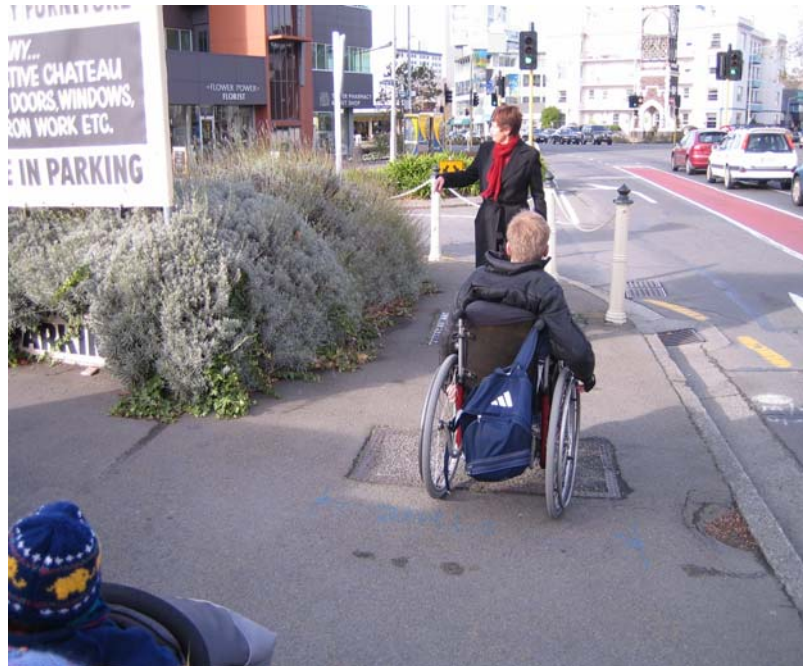
Heading towards Montreal Street was the greatest challenge for everybody. We all wanted to walk straight ahead in Victoria Street but chains prevented us from going in the direction we wanted to be in. There was no signage or clear path to indicate where the footpath went. Our mobility instructor pointed out the chains were the wrong height and color for a visually impaired person to detect. They should be at a maximum height of 150mm from the ground. These chains were

much higher than that, meaning that a person with a cane could not locate them in time to avoid falling over them. A stronger color would also aid in their detection.

Chains prevent us from walking straight ahead.
Victoria/Montreal/
Salisbury Streets

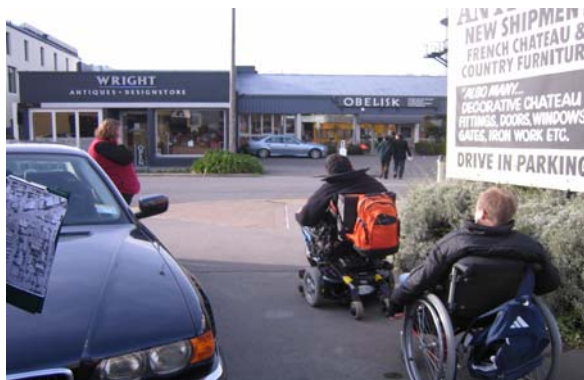
We have to navigate through the antique store car park to cross Salisbury St to get back to Victoria St.

We had to navigate our way through what looked like a car park. There was no signage for the route direction. The antique shop on the corner seemed to be allowed to take the footpath as car parking for its business needs. For our visually impaired walker this area was quite difficult without assistance from a sighted person. There was no tactile paving for guidance and the chain fencing was too high for them to find before tripping over it.

- Making sure that entrances to car parks are clearly delineated to highlight that walkers have the right of way. Adequate pavement markings would solve this problem.

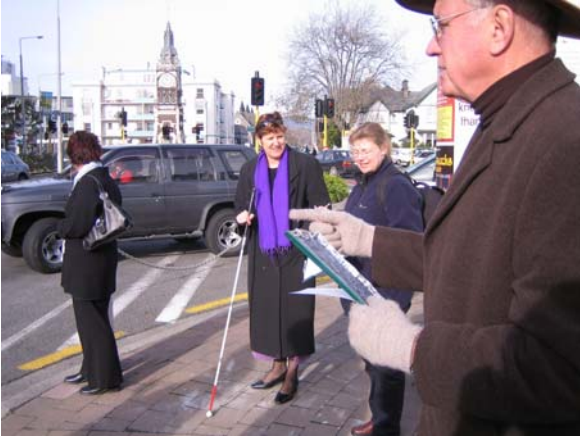
Crossing the road was not easy at the designated crossing point. Blind left-hand turners came from Victoria Street. It was difficult for people who were slow to navigate the crossing point. The entire intersection needed to be realigned and left hand turns banned. One participant felt traffic movements should be altered and cars traveling north on Montreal should not be able to enter Victoria Street.

Left hand turners make road difficult to cross.

- The left hand slip lane onto Montreal St from Victoria should be closed and direct pedestrian access established to cross the road.
- Traffic should be slower for the entire area. Now that council has more influence in setting local speed limits, a slower traffic speed of 30km should be implemented in this area.

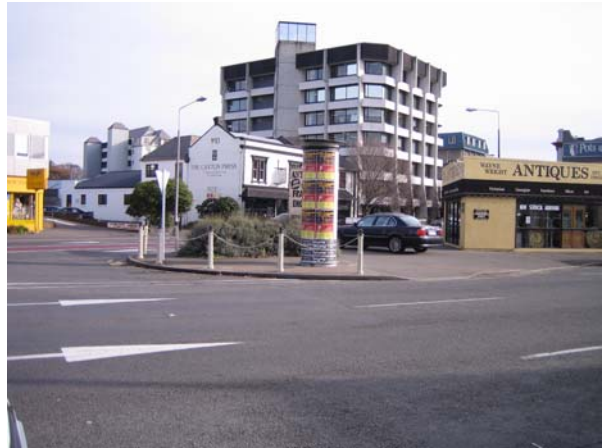
Poster tower impedes sight lines for wheelchair users.

This intersection was also incredibly difficult for our wheelchair users. A large poster bollard in the pavement blocked their sight lines. You can just see this in the photo.

- Streets should be cleaned more often.
- Poster bollards should not be installed on intersection edges because they impede sight lines for some people.

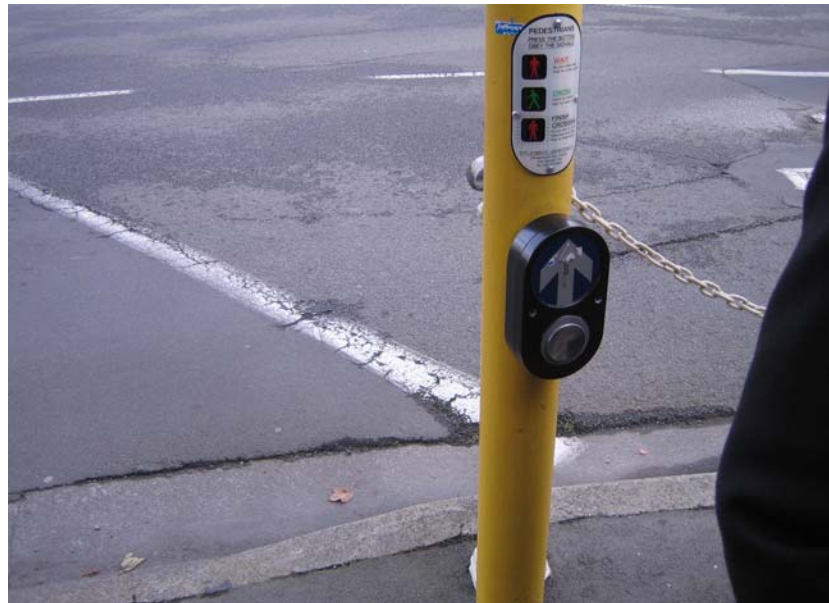
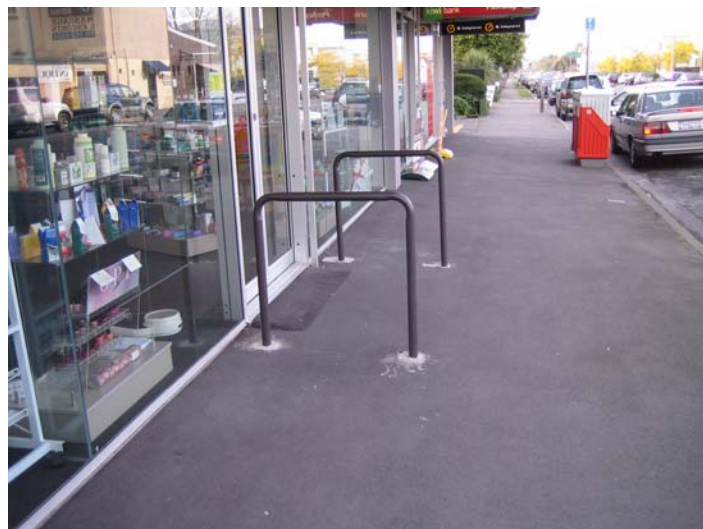
We arrived at another chained intersection. This was Salisbury St. Our visually impaired walker pointed out a very interesting design defect. The arrow on the pedestrian lights should point in the direction of the crossing. This one doesn't and points the person into the centre of the intersection. Again there was no tactile paving for directions. For the rest of us the length of time that the green man flashed was really short. There was not enough time for people to get over the road easily.

When we looked to our left in Salisbury Street we found a terrible example of the path being obstructed by hand rails. This was particularly dangerous for the visually impaired.

- Closer attention needs to be paid when installing traffic lights to ensure walk arrows align with the intersection for vision-impaired and that poles are at an appropriate distance from the kerb for vision impaired and wheelchair users. Again this is a matter of ensuring contracting staff is aware of RTS 14.

- Traffic light signals should have longer green cycles. People feel intimidated when the red man flashes almost immediately. This was particularly a problem heading south on Victoria Street and trying to cross Salisbury. There should be a review on how traffic signals for pedestrians work.

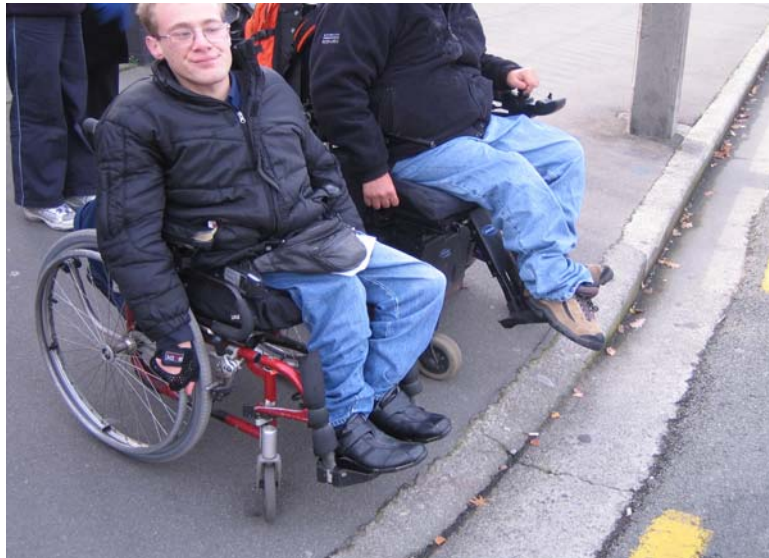
Whilst we didn't cross over the road to the casino we made some observations from the footpath. Signage was terrible. Small signs pointing to London etc were a waste of money. Trees that were planted in the middle of the footpath were also quite amusing. For our wheelchair users they appreciated the small island in the centre of the road but had great difficulty with the kerb cuts.

- There should be an immediate program to improve kerb cuts. Poor kerb cuts limit access for some people. An audit of poor kerb cuts should be undertaken now and improvements built into a forward works program.

- Pedestrian signage and maps need to be developed for the entire area. Christchurch City needs to develop some uniform pedestrian map and signage standards. To my knowledge this has not happened.

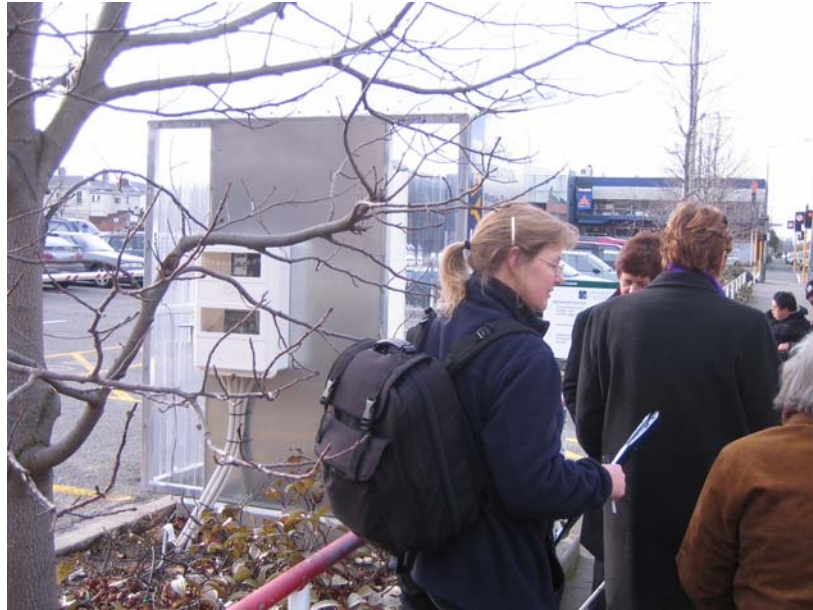
Alongside the car park were overhanging trees. The branches were a problem for the visually impaired walker. Trees need to be trimmed regularly so that they don't cause injury to people. Patricia made another interesting comment at this point. The free shuttle bus travels along this route but only in the evening. For her travel needs and many others it would be a great idea to have the service operating day and night. This would reduce the walking distance into the central city for both herself and many other elderly residents who live in the vicinity.

Dangerous tree branches in Peterborough St.

- Trees should only be planted on footpaths at the road edge and when this is done branches should be trimmed regularly to ensure branches don't scratch people. Foliage on properties that overhangs the walking environment should be trimmed regularly if council owned and if privately owned, council should notify the owners to trim if there is a problem.

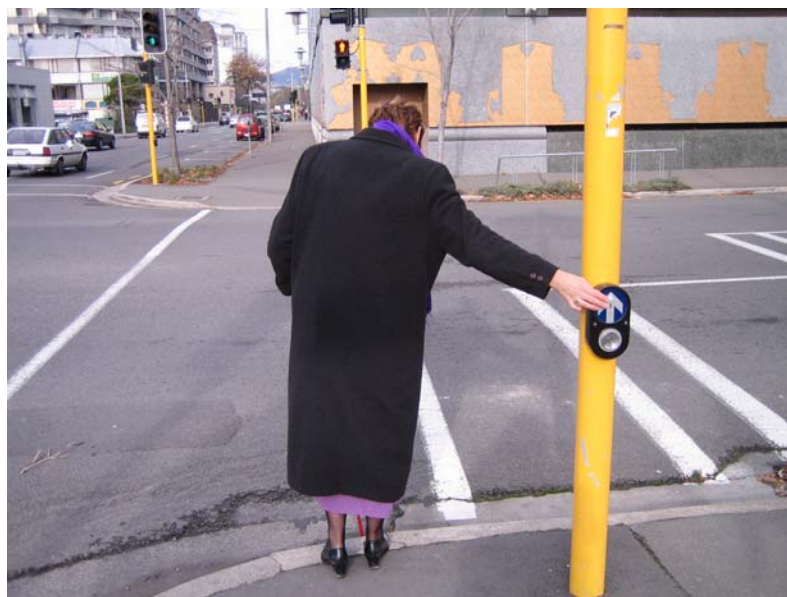
We turned the corner into Durham Street and headed north. For a very central city area it was an extremely ugly area. Very gray and boring. Filled with car movements and not much else. One positive comment was the area was very well lit. Again there were no tactile pavers for directions and the kerb cuts were extremely difficult for our wheelchair users and the mother with the pushchair. The curb extensions were not located properly at the crossing. For a blind user when they find the light button they should be a body length from being able to move onto a smooth intersection. In this case they will trip because the kerb extension is in the wrong place. The photo also shows the pole is too far away from the road edge, it is quite difficult for this lady to reach.

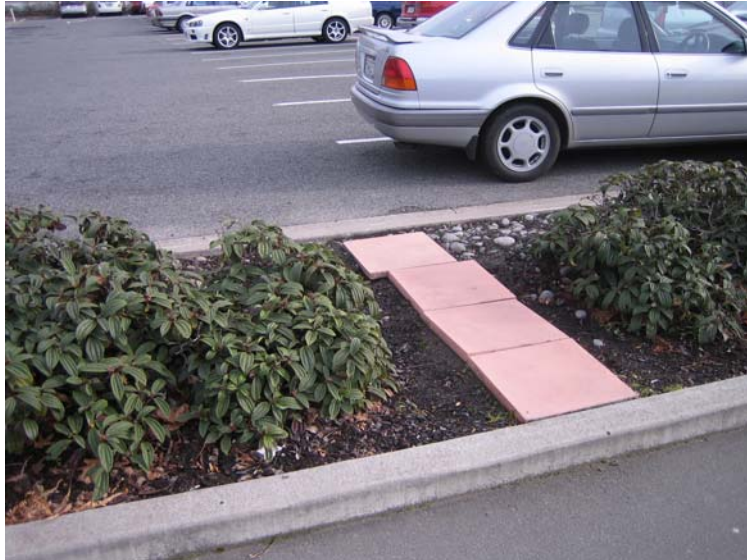
We found evidence of pedestrian desire lines not being fulfilled in this area. The car park had no proper pedestrian connections from it to the street. People walked

through the flower beds. Someone had taken the initiative to place some pavers between the beds but they were not laid correctly and were impossible for a wheelchair user, a frail person or a mother with children to use. The remainder of the street was undulating. We think it has been a long time since the path has been re-surfaced.

- Undertaking more regular maintenance to ensure footpath surfaces are smooth.
- Putting utility covers on the road edge or covered with a smooth cover. Covers could be applied to existing utility points and new installations could be made roadside.

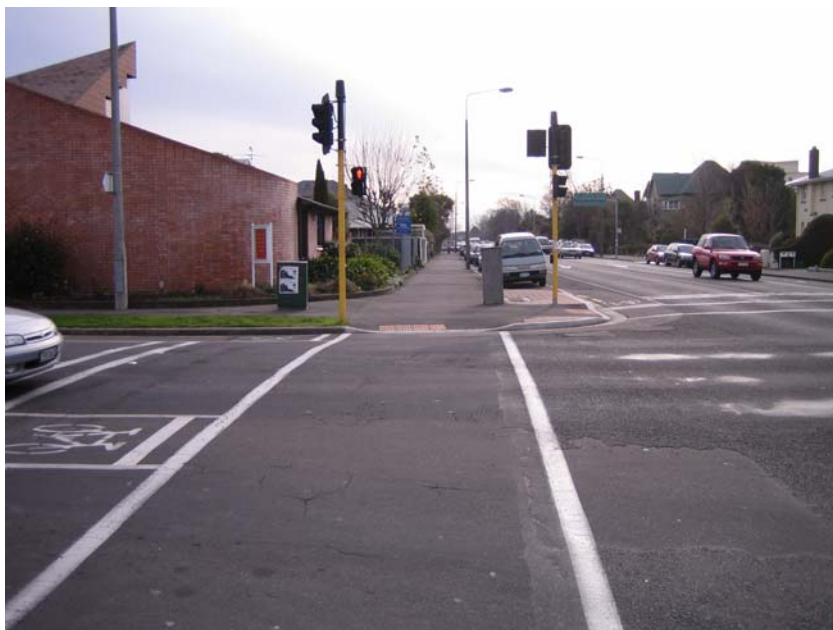
Tactile paving was laid on the north west corner of the intersection of Salisbury St and Durham Street North. However although new, there were installation problems. The tiles were right on the road instead of being 300mm from the intersection. When visually impaired people find the tiles they need a little bit of space so they don't end up on the road space. The other problem with the tiles they didn't align with the intersection. They directed people into the oncoming cars and not the crossing point.

- Ensuring tactile paving is installed according to RTS 14. Council staff should be aware of RTS 14 and ensure contractors have sufficient knowledge to perform correct installations. As we found new installations are not being installed correctly.

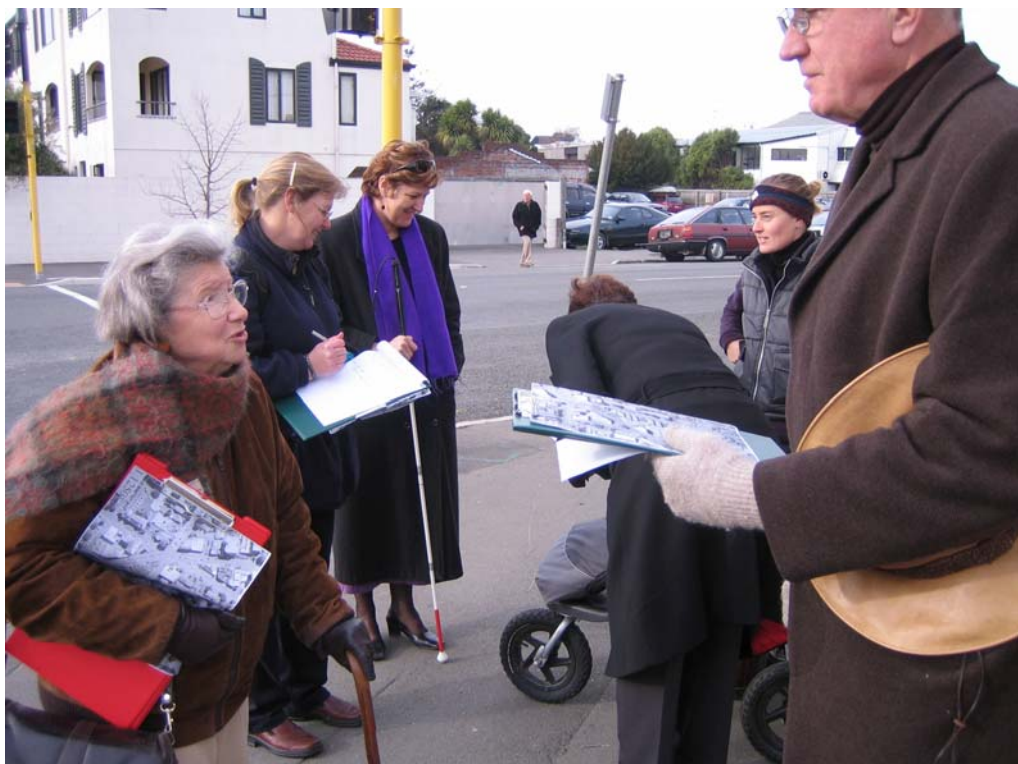
Our walk concluded when we reached Victoria Street. We summed up what we had seen. Many general comments were made at this point. On the route we took there were no seats, for mothers and older people they want to sit and rest at times. There were no toilets. Everyone commented that there were no pedestrian signs or maps for people new to the area. For an area promoted to tourists you would easily get lost if you didn't have your own map. Bus stops were lacking as well.
